# 5 Stroke Development Review

8<sup>th</sup> January 2008

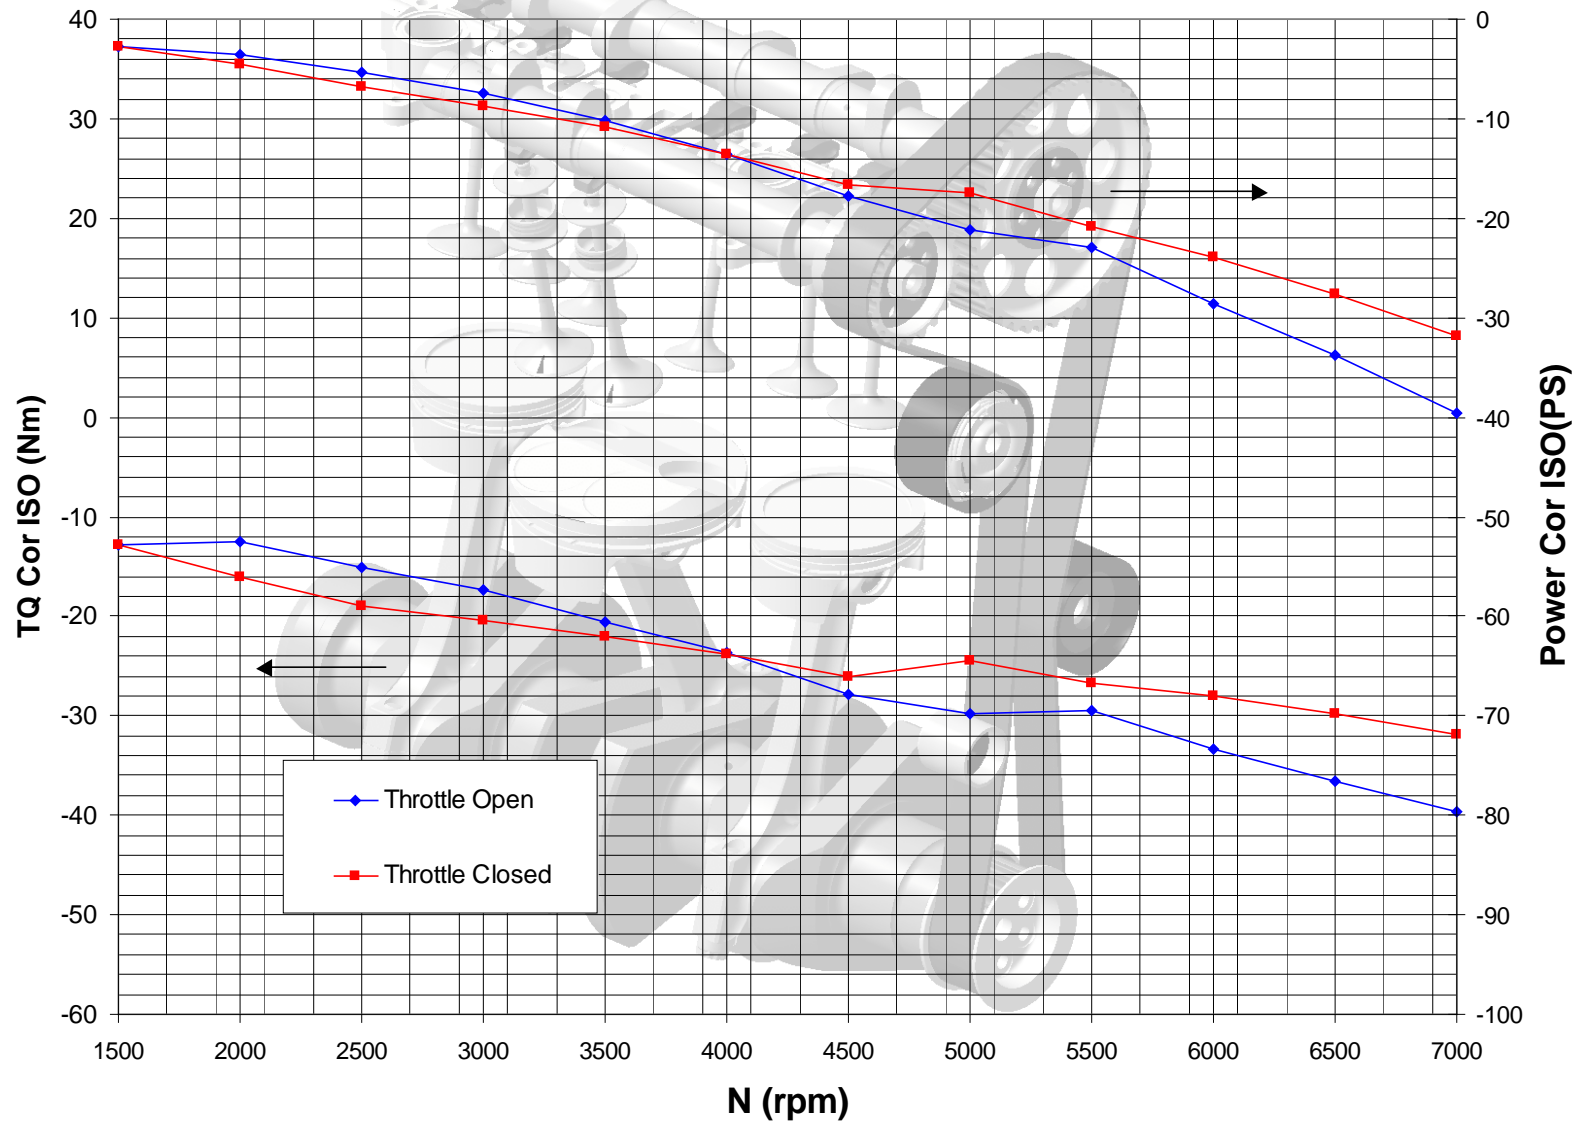
# Chart 1 Motored Curve

- High motored power consumption possibly due to pumping losses between un-fired cylinders
- Future work to evaluate pure frictional losses?

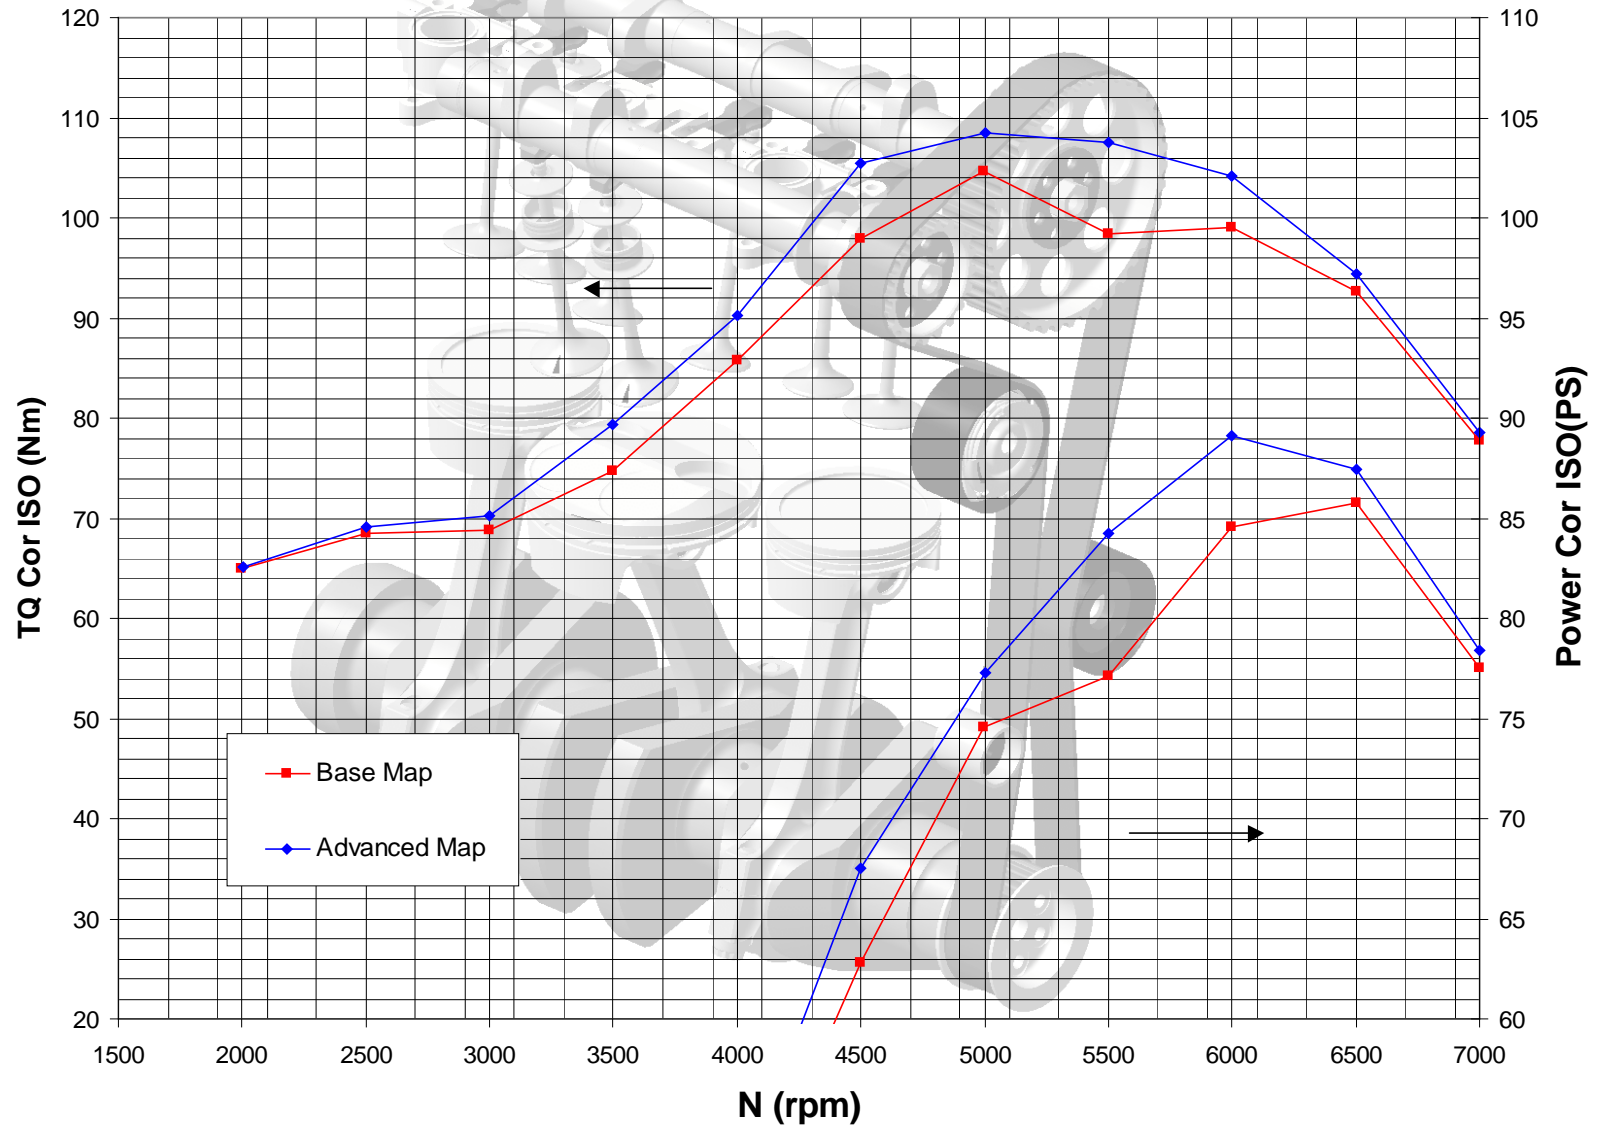
# Chart 2 Spark Sweeps – Torque and Power

- Improvement on BSFC
- Higher performance figures achieved

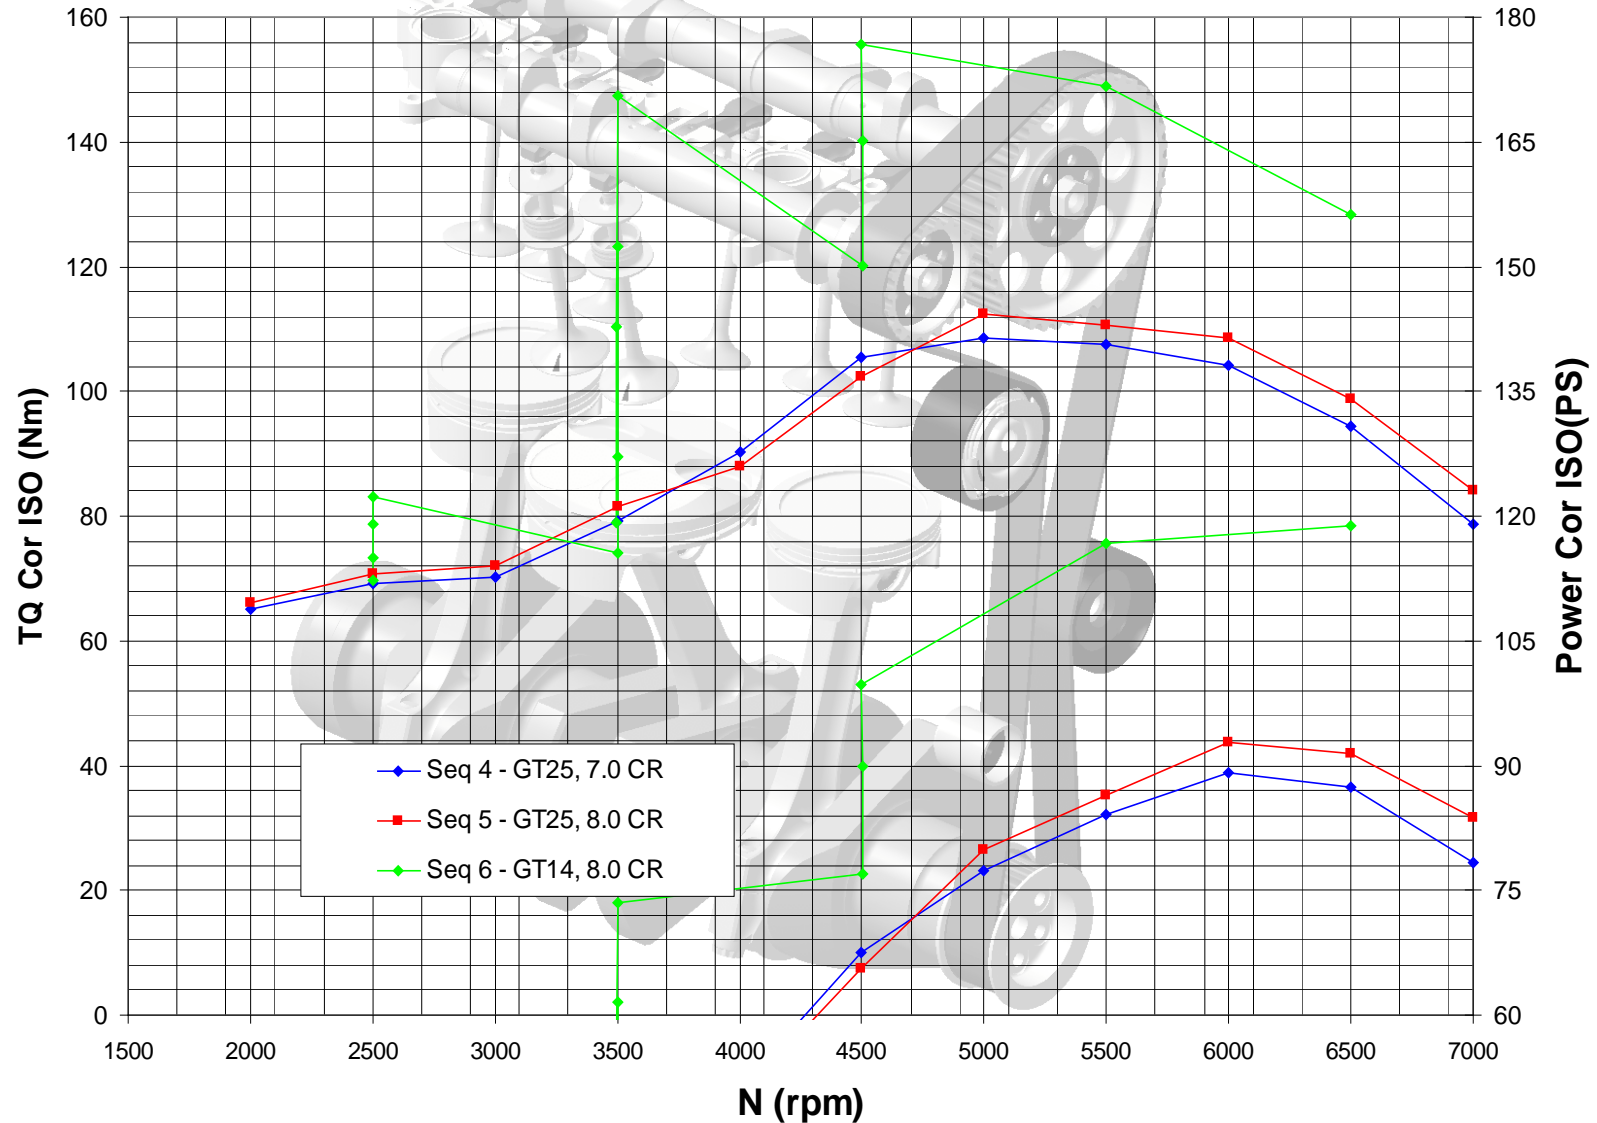
# Chart 5 Sequence 5 & 6 – Torque and Power

- CR increased from 7:1 to 8:1
- BSFC and power improvement

- Returned to GT14 with revised VNT control
- 3 bar boost now achievable
- Engine knock limited with high combustion variability
- Performance improvement at expense of BSFC
- Over fuelling required to control exhaust gas temperatures

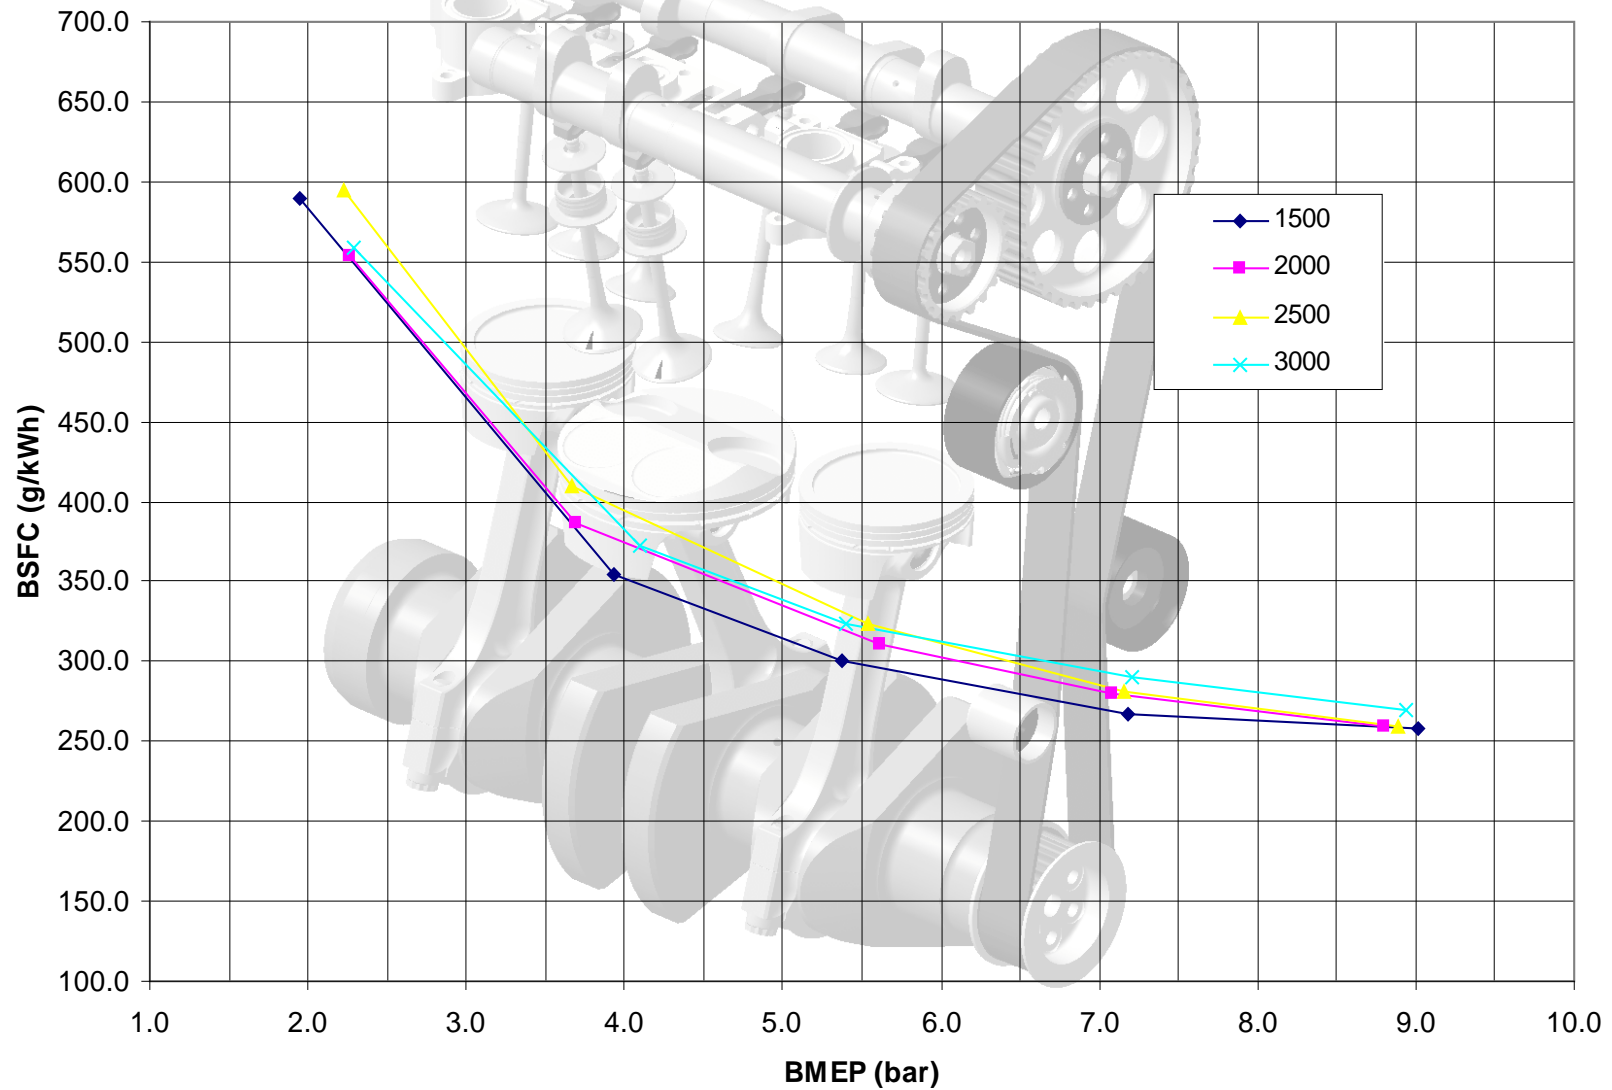
# Chart 8 Part Load Summary

- Poor part load consumption achieved
- Limited by rate of combustion

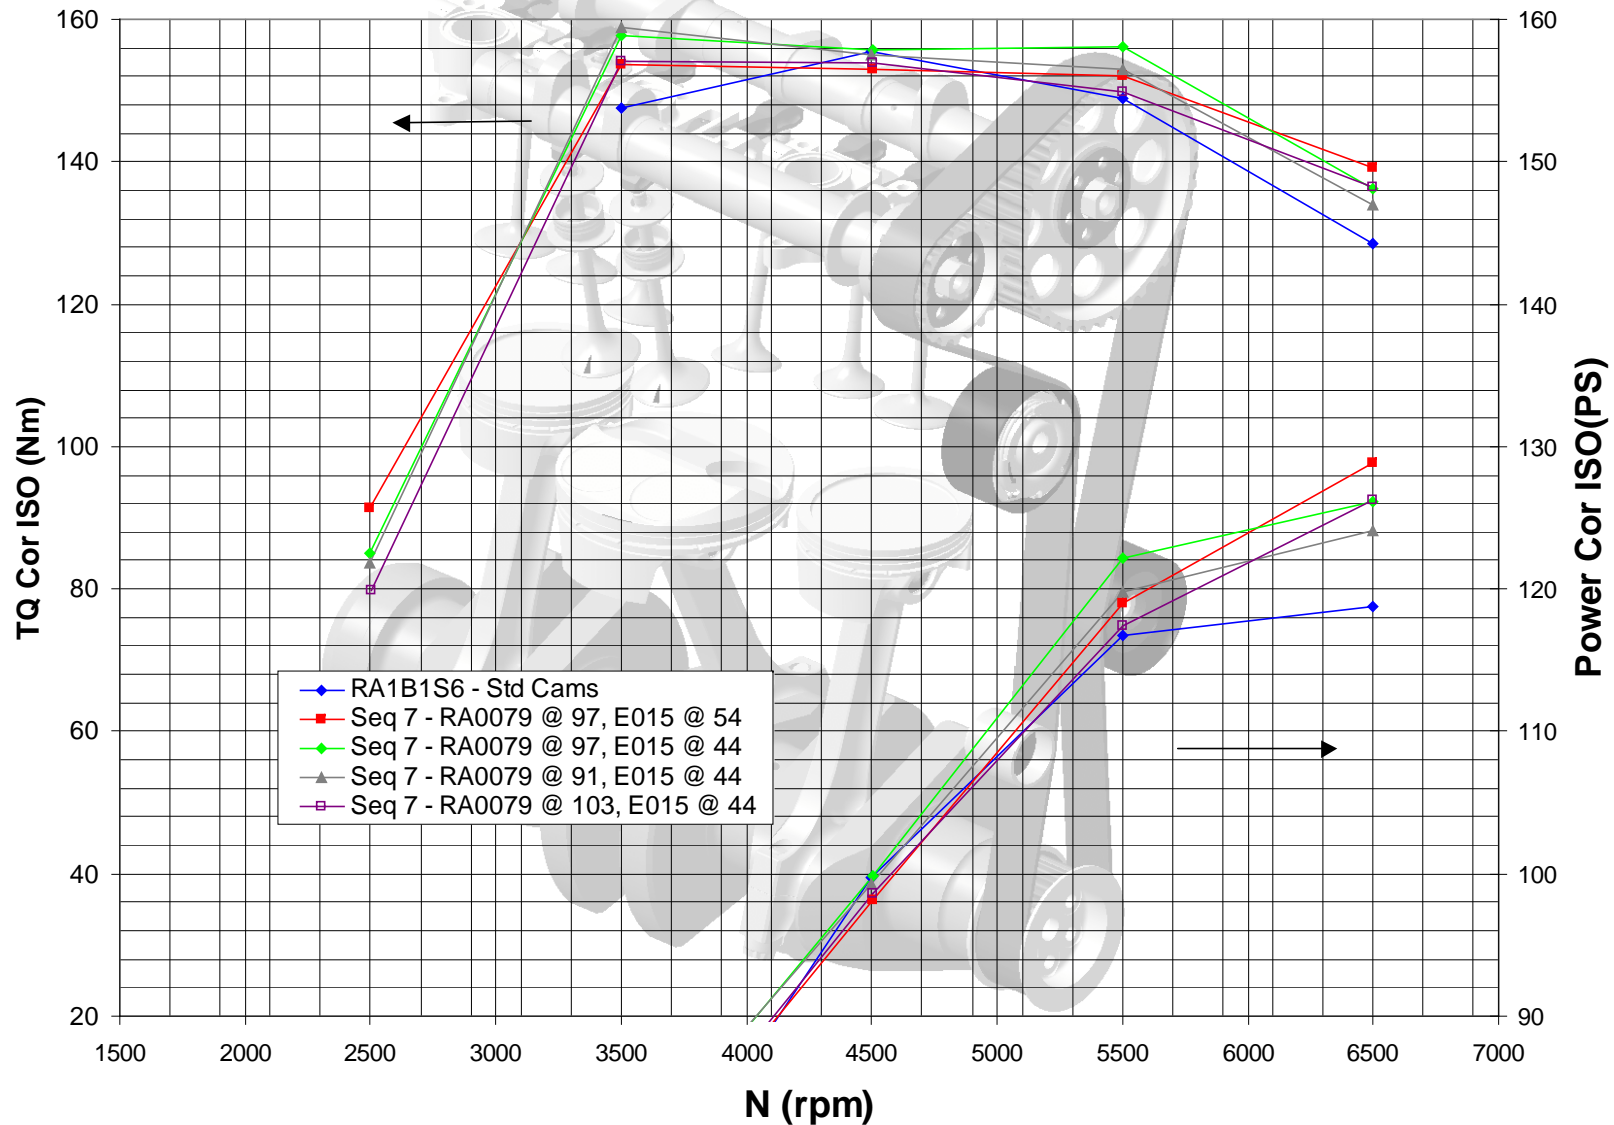
# Chart 9 Sequence 7 – Torque and Power

- Longer exhaust camshaft fitted with same opening point
- Improved performance at top end and small change in BSFC

- Variations on HP and LP cam timings
- No improvements to be made on BSFC

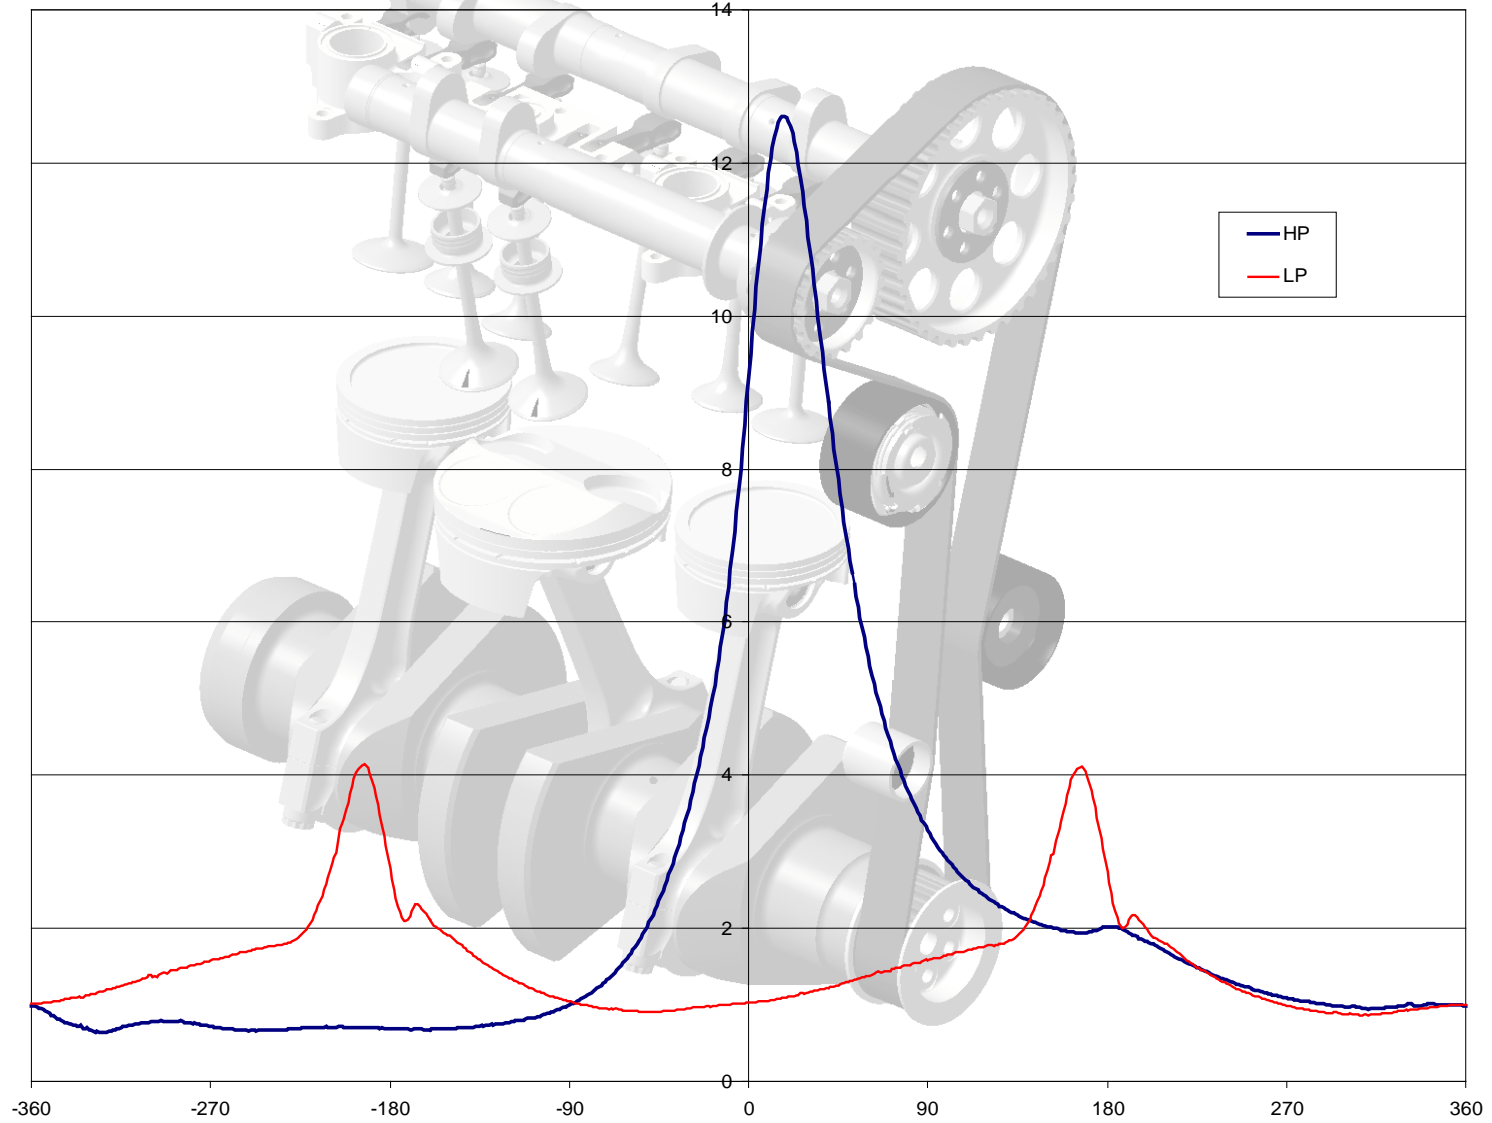
# Chart 11 Indication Measurements – Part Load

- High percentage of negative work present at low load sites
- Reverse flow present in transfer port due to low combustion pressures in HP cylinder
- Negative work not present at full load
- Charts show data for 2500 rpm at full and part load
